McCarthy Road Planning and Environmental Linkages (PEL) Study
AK FLAP DOT 198(4)

Needs and Opportunities Assessment Report
March 2024

Prepared for:
Federal Highway Administration Western Federal Lands Division

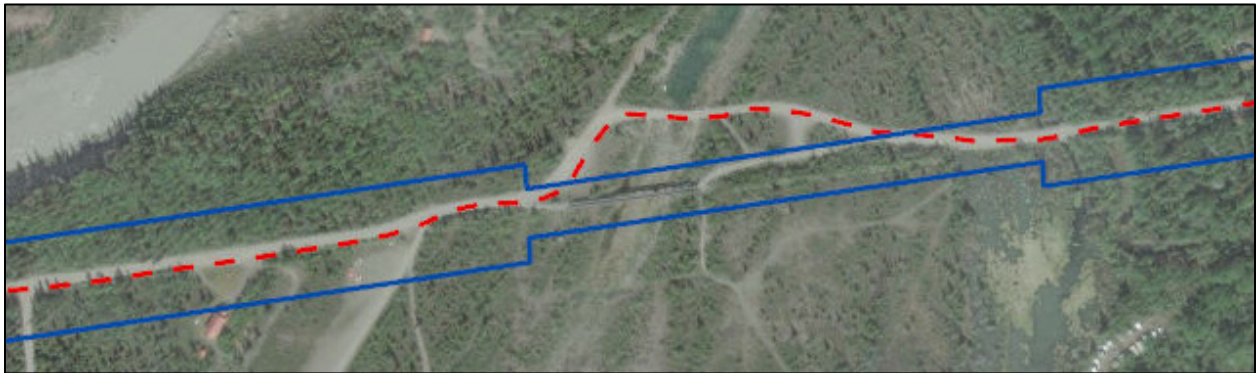
Figure 4-8. Road ROW Discrepancy East of Kennicott River Crossing near Community Swimming Hole

Figure 4-8, respectively. On these figures, the red dashed line follows the road centerline. The blue line depicts the actual ROW boundary that does not match the road centerline.

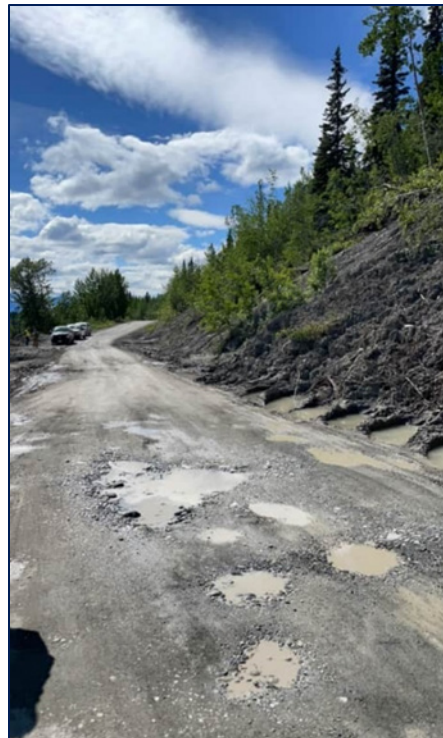
Figure 4-12. McCarthy Road Conditions near MP 58

For the rest of the study corridor that is not included in these data, information gathered from field inspection and discussions with maintenance was utilized. Overall, the roadway is in fair condition with areas that are in poor condition based on drainage or geological issues. Figure 4-12 shows a portion of the McCarthy Road that is experiencing these issues even during a dry portion of the summer.

Image taken during June 2023 site visit.

The existing roadway will benefit from drainage and geotechnical improvements to reduce potholes, standing water, sloughing, and overall road damage. Other reported roadway issues are railroad spikes (from overlaid railroad ties), washboard sections, soft shoulders, and road base failure.

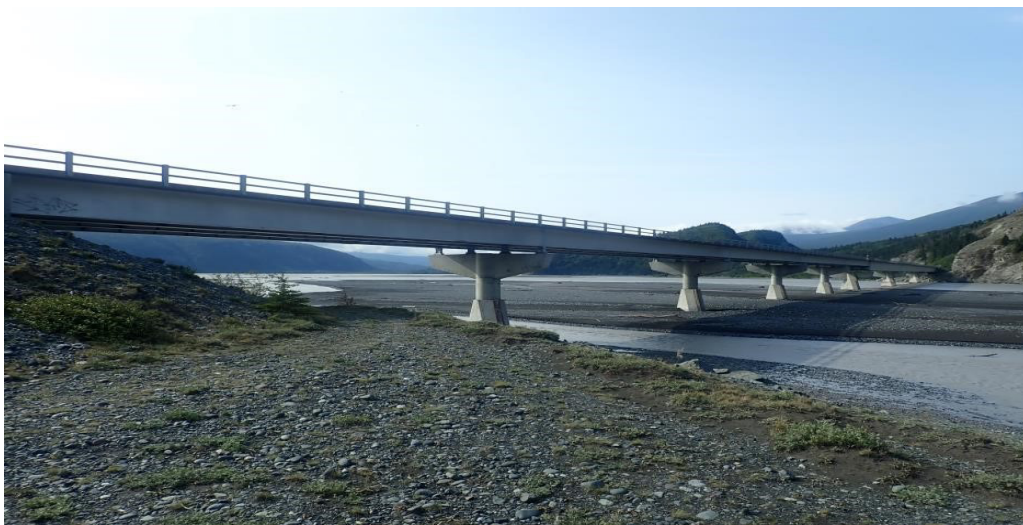
Figure 6-2. Copper River (Chitina) Bridge (BR 0205), Upstream Looking Downstream

Figure 6-2 shows the Copper River crossing, located on the west end of the study corridor. Near MP 1.2, Copper River flows north to south under the McCarthy Road corridor existing 1,378-foot-long, eight-span bridge structure (Figure 6-2) built in 1971. The Copper River combines with the Kotsina River upstream from the bridge and combines with the Chitina River downstream of the bridge. This bridge does not include any skew or flaring with the Copper River. Full-sized trees have been observed within the riverbed as potential driftwood clogging. Existing riprap armoring has been observed to be in fair condition with minor repairs needed. The DOT&PF staff has identified the possible need for future bridge abutment work.

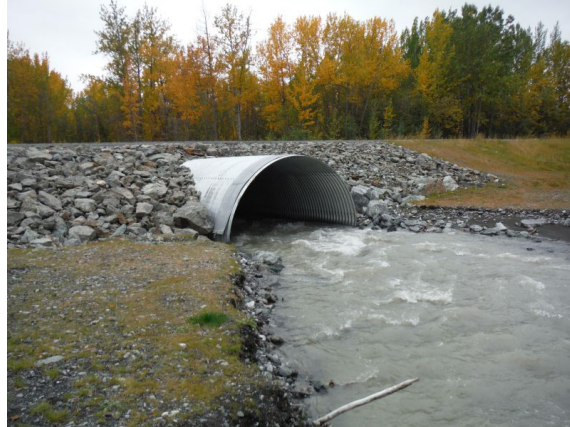
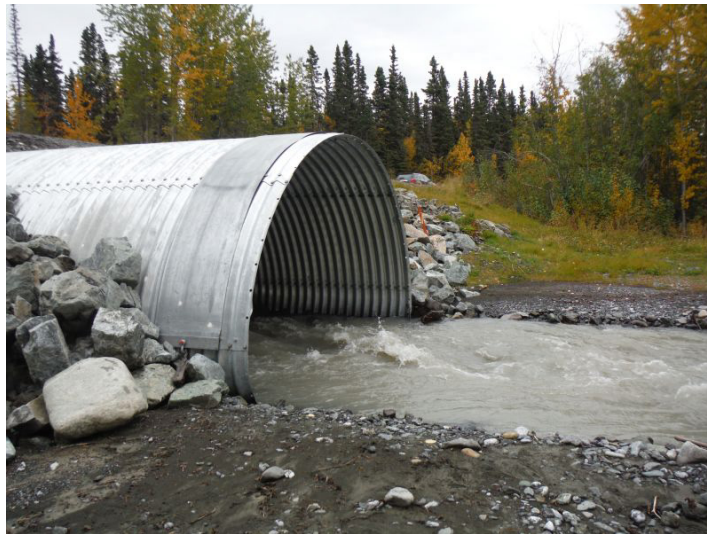
Figure 6-3. Strelna Creek Culvert (BR 7183), Downstream Looking Upstream

Figure 6-4. Strelna Creek Culvert (BR 7183), Looking at Upstream End of Culvert

This culvert was replaced in 2013 because the previous culvert was undersized. The CRWP data have identified this current culvert to include high velocities through the pipe. A major bank collapse and erosion has been identified approximately 300 feet upstream of this crossing (CRWP 2024).

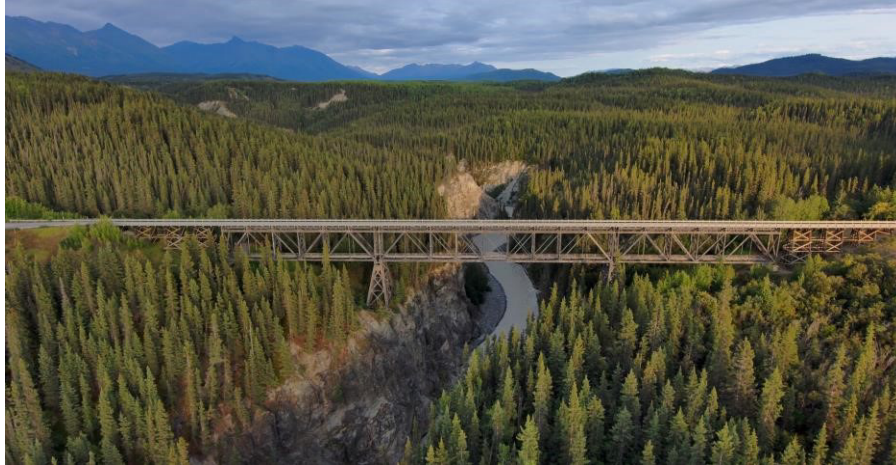
Figure 6-5. Kuskulana Bridge (BR 0397), Downstream Looking Upstream

Figure 6-5 and Figure 6-6 shows the Kuskulana River crossing. Near MP 17, the Kuskulana River crosses the McCarthy Road from the east, under the existing 775-foot long, triple-span bridge structure (BR 7183) built in 1910. The Kuskulana River flows and continues west to combine with the Strelina Creek, then flows into the Chitina River. Vertical clearance over the river has been observed to be more than adequate with minimal scour risk due to the foundations being built on bedrock outside of the river floodplain.

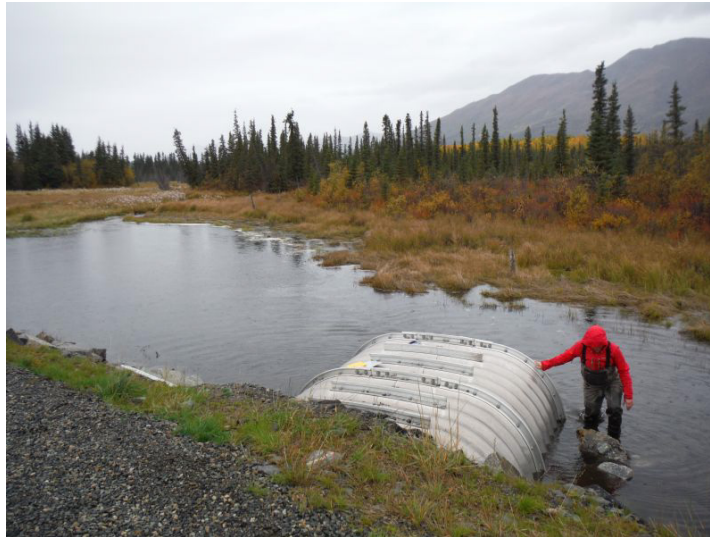
Figure 6-7. Chokosna River Tributary (MC 15) Cross Culvert, Upstream Side Looking South

As this Chokosna River Tributary approaches the McCarthy Road corridor, it ponds up on the northern side due to flat wetlands and beavers damming the water. The tributary downstream of the crossing is also ponded up because of flat wetlands.

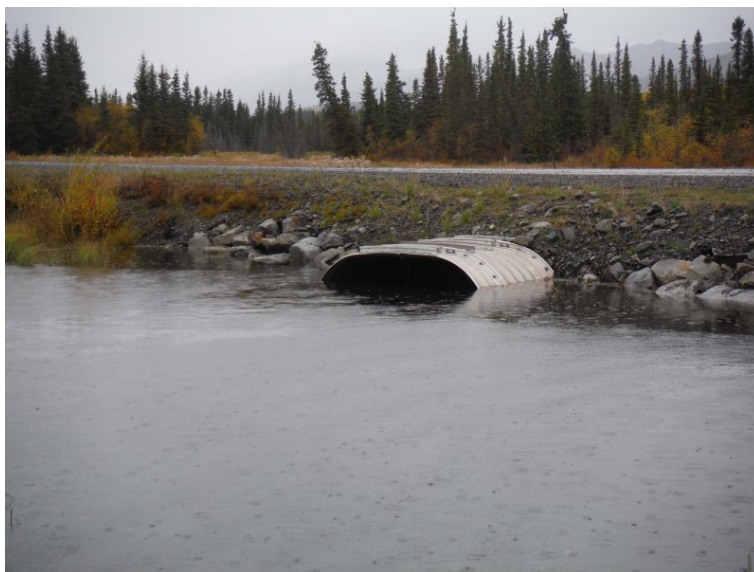
Figure 6-8. Chokosna River Tributary (MC 15) Cross Culvert, Upstream Looking Downstream

This is a relatively new culvert with beaver complexes that frequently appear upstream of this crossing. Interconnecting deeply incised channels with increasing gravels have been identified further upstream. Adult and juvenile coho salmon have been identified here. (CRWP 2024)

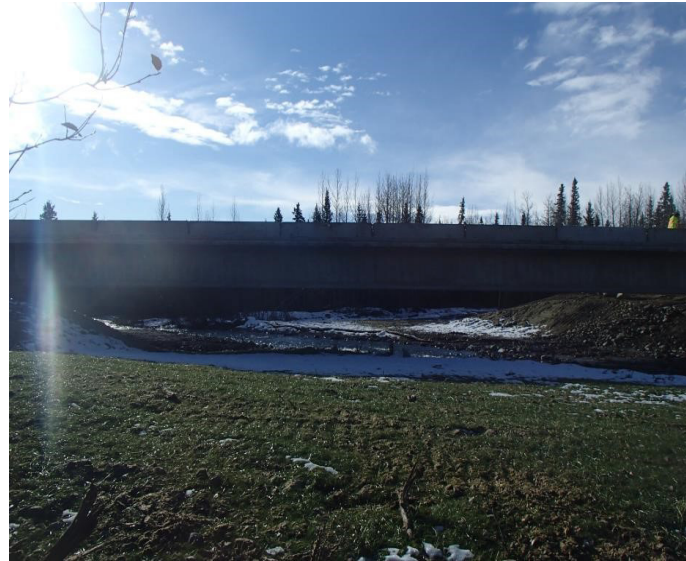
Figure 6-9. Chokosna River Bridge (BR 1193), Upstream Looking Downstream

The riverbed is composed of gravel and cobbles. The bridge abutments are armored with moderately sized riprap, and the river shows signs of potential migration outside its existing banks. The western bank upstream from the bridge has been armored with moderately sized riprap but shows signs of erosion.

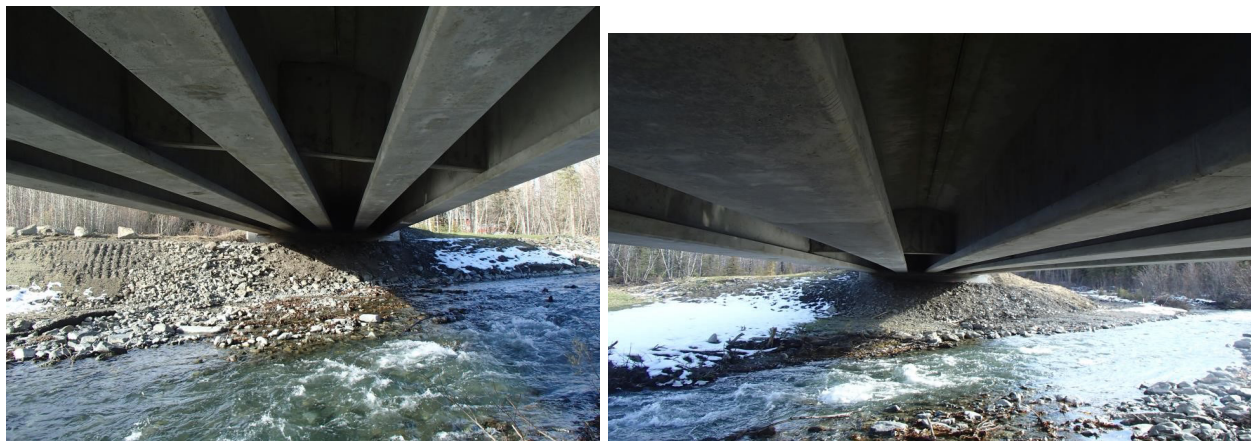
Figure 6-10. Chokosna River Bridge (BR 1193), Looking Upstream, Right and Left Abutment

Figure 6-9 and Figure 6-10 show the Chokosna River crossing. Near MP 26.8, the Chokosna River crosses the McCarthy Road from the north within a 146-foot long, single-span bridge structure (BR 1193) built in 2021. This bridge has an approximate skew of 30 degrees to the river.

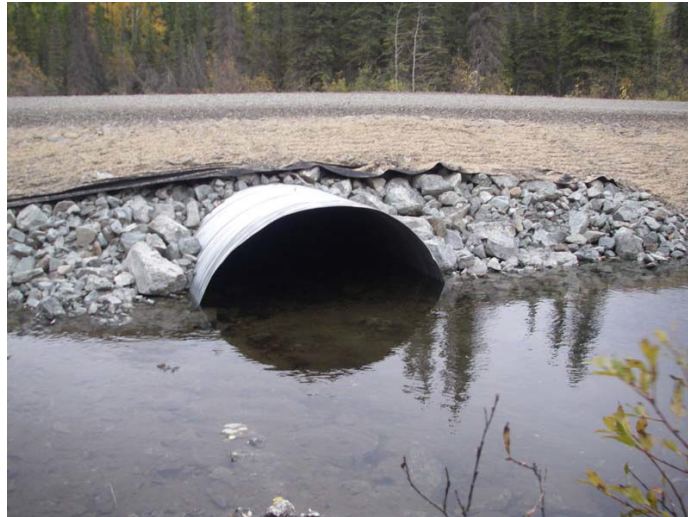
Figure 6-11. Chokosna River Tributary (MC 13), Upstream End Ponded

The upstream end of this crossing is a flat wetland with very low flow causing ponding in the area. The upstream roadway side slope is armored with moderately sized riprap protecting the area around the culvert from erosion. The area downstream has a moderate slope and conveys the water west of the corridor to the Chokosna River.

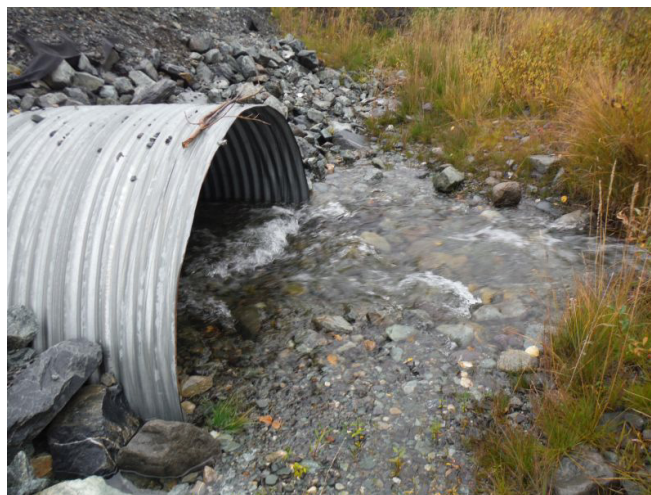
Figure 6-12. Chokosna River Tributary (MC 13), Looking Downstream End

Figure 6-11 and Figure 6-12 show the Chokosna River Tributary crossing. Near MP 26.9, the Chokosna River Tributary (MC 13) crosses the McCarthy Road from the eastern side to the western side. This structure, named MC 13 by the CRWP database, was observed to be in good condition.

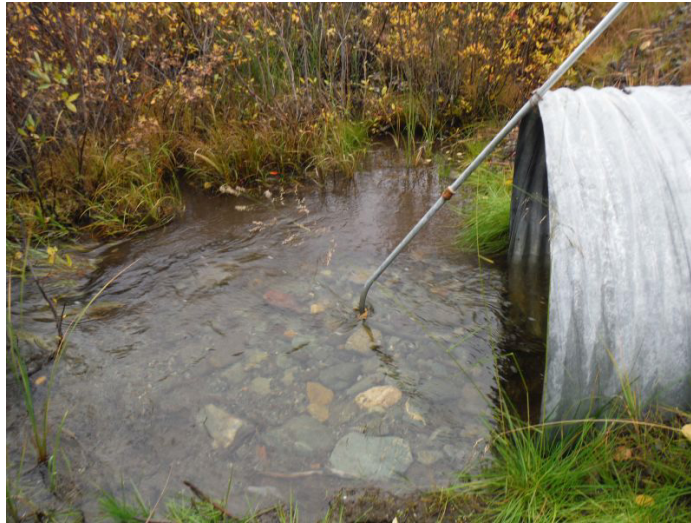
Figure 6-13. Chokosna River Tributary (MC 12), Upstream End Ponded

The upstream end of this crossing is a flat wetland with very low flow causing ponding in the area. The upstream roadway side slope is armored with smaller sized riprap protecting the area around the culvert from erosion. The area downstream has a moderate slope and conveys the water west of the corridor to the Chokosna River.

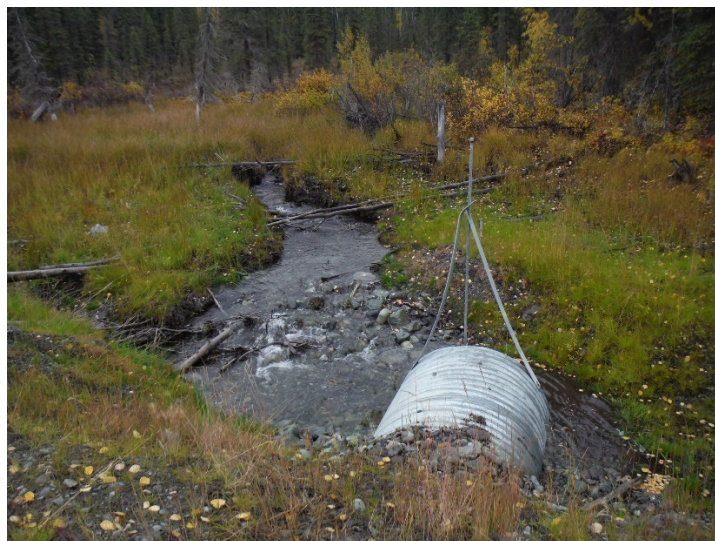
Figure 6-14. Chokosna River Tributary (MC 12), Looking Downstream

Figure 6-13 and Figure 6-14 show the Chokosna River Tributary crossing. Near MP 27, the Chokosna River Tributary (MC 12) crosses the McCarthy Road from the eastern side to the western side. This structure, named MC 12 by the CRWP database, was observed to be in good condition.

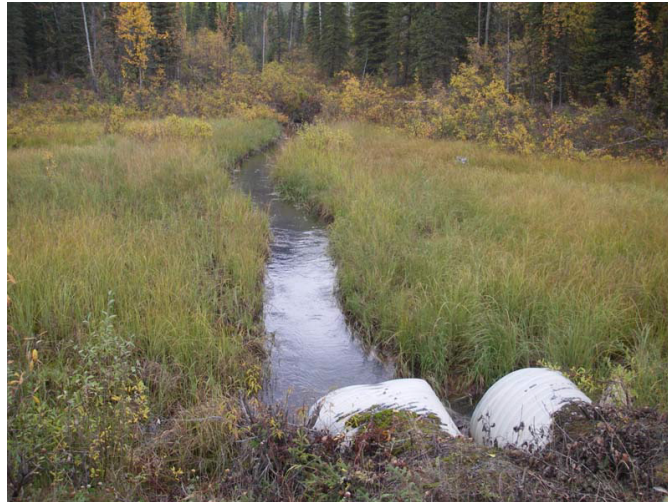
Figure 6-15. Chokosna River Tributary (MC 11), Downstream Looking Upstream

Figure 6-15 and Figure 6-16 show the Chokosna River Tributary crossing. Near MP 27.3, the Chokosna River Tributary (MC 11) crosses the McCarthy Road from the northeastern side to the southwestern side. This structure, named MC 11 by the CRWP database, was observed to be in good condition.

The tributary combines with the Chokosna River about 0.25 mile southwest from the major crossing. At the major crossing, the tributary crosses the corridor within a triple-barrel 36-inch CSP culvert.

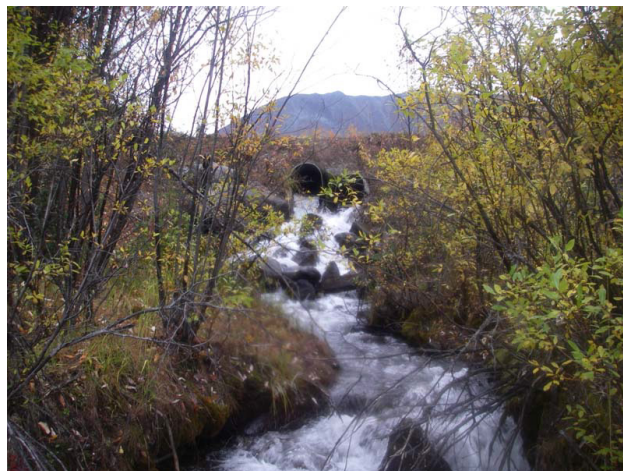
Figure 6-16. Chokosna River Tributary (MC 11), Downstream Looking Upstream

Upstream from the crossing, the tributary is fed by overflow from three unnamed ponds. The area immediately upstream from the crossing is gradually sloped grasslands area. The area downstream has a moderate slope and conveys the water west of the corridor to the Chokosna River. The roadway side slopes on either side are not armored with riprap, and there are signs of erosion around the culvert.

There is a significant change in streambed elevation from the inlet end to the outlet end of the culvert affecting stream bed stability. Head cutting and channel over-widening is occurring upstream and downstream of this crossing. Channel stability increases approximately 130 feet downstream of this crossing and offers good habitat for spawning and rearing. (CRWP 2024)

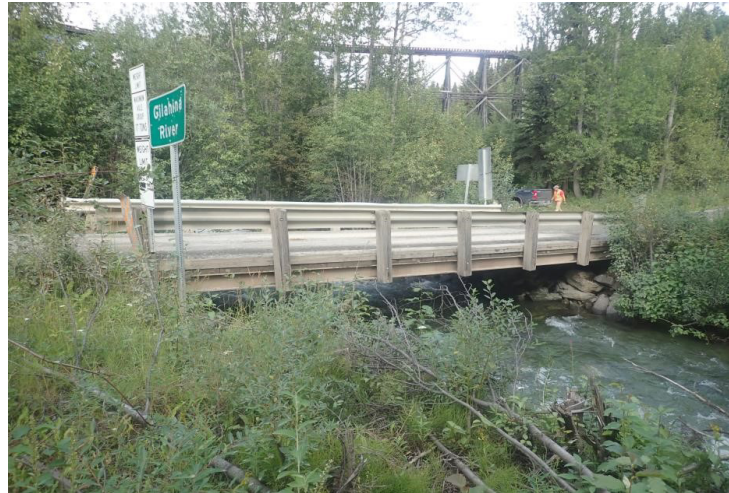
Figure 6-17. Gilahina River Bridge (BR 1194), Downstream Looking Upstream

The bridge abutments are armored with large-sized riprap. The river does not show signs of potential migration outside its existing banks. The river is moderately sloped, and the bed is made up of large cobbles and rock that do not appear to be aggregating. Small branches were observed around the abutments at the waterline that represents potential for driftwood impacts. The DOT&PF M&O staff has identified that this bridge needs to be replaced. It was observed that scour occurs at abutments, debris gets into girders, and a higher bridge clearance is needed. Throughout all of the vehicular bridges in this study corridor, the Gilahina River bridge (BR 1194) has the highest load restriction.

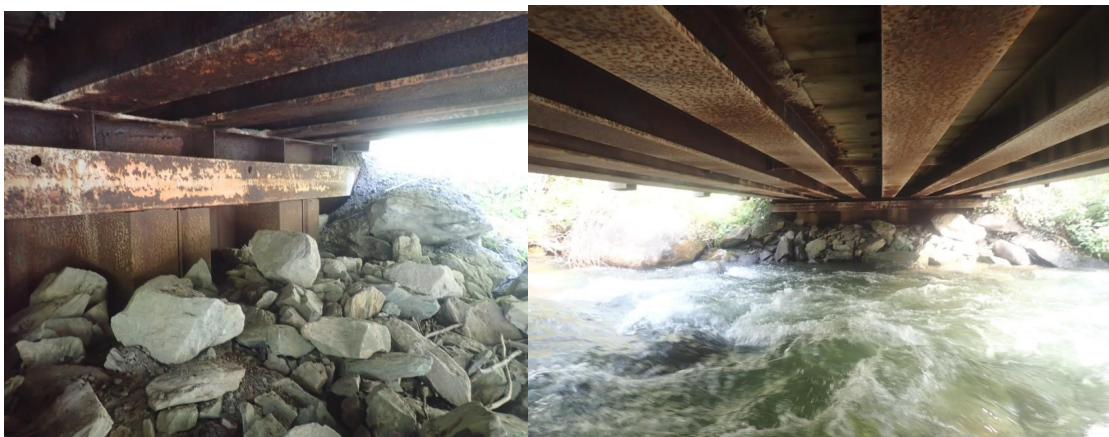
Figure 6-18. Gilahina River Bridge (BR 1194), Looking Upstream, at Left and Right Abutment

Figure 6-17 and Figure 6-18 show the Gilahina River bridge crossing. Near MP 28.9, Gilahina River crosses the McCarthy Road from the north within a 41-foot-long, single-span bridge structure (BR 1194) built in 1991.

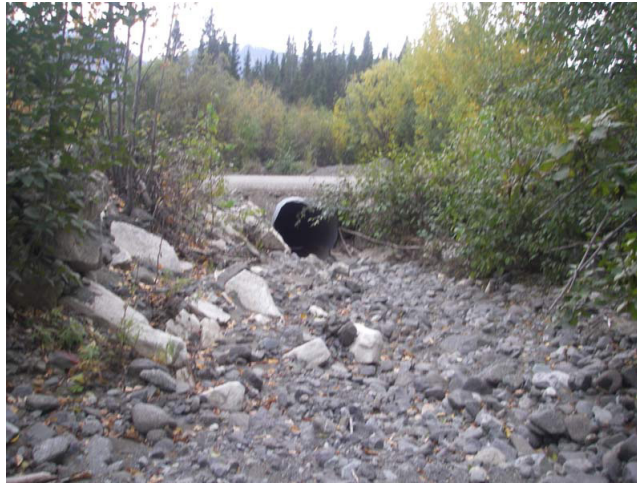
Figure 6-19. Ruth Creek Cross Culvert (MC 10), Upstream Looking Downstream

This creek appears to be a dry creek the majority of the year, only getting flow from spring snow melt. The creek does not show signs of potential migration outside its existing banks. The upstream creek bed is moderately sloped and is made up of medium-sized cobbles. Downstream of the cross culvert, there is an open area with about a 3-foot-tall berm to channel the creek south where it combines with Crystal Creek.

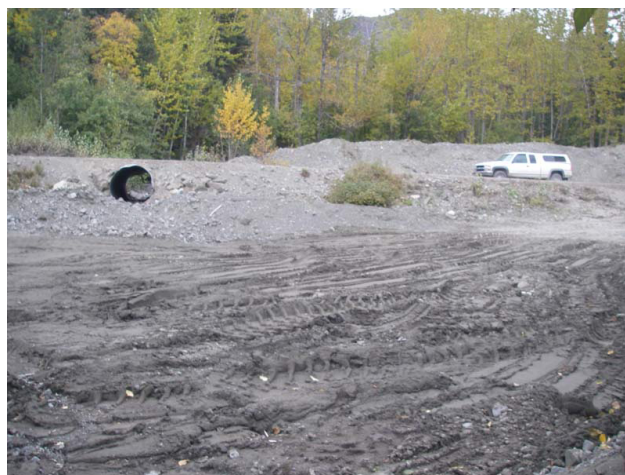
Figure 6-20. Ruth Creek Cross Culvert (MC 10), Downstream Looking Upstream

Figure 6-19 and Figure 6-20 show the Ruth Creek crossing. Near MP 40.3, Ruth Creek crosses the McCarthy Road from the north within a 60-inch CSP culvert structure. This structure, named MC 10 by the CRWP database, was observed to be in good condition.

This crossing has been recommended for an upsized pipe culvert by the DOT&PF maintenance staff. It has also been observed to include horizontal channel migration in the past and includes the potential for future horizontal migration.

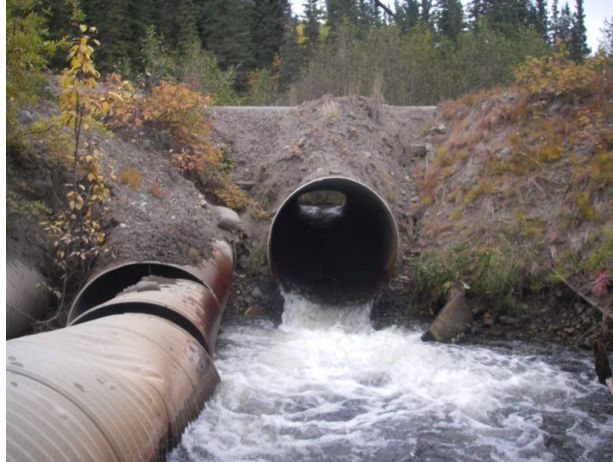
Figure 6-21. Crystal Creek (MC 9), Downstream Looking Upstream (pre-improvement project)

The upstream end of this crossing is a flat wetland with very low flow, causing ponding in the area. The roadway side slopes are armored with rock armor that was installed as part of the recently completed project. The area downstream has a moderate slope and conveys the water west of the corridor to the southwest to the Lakina River.

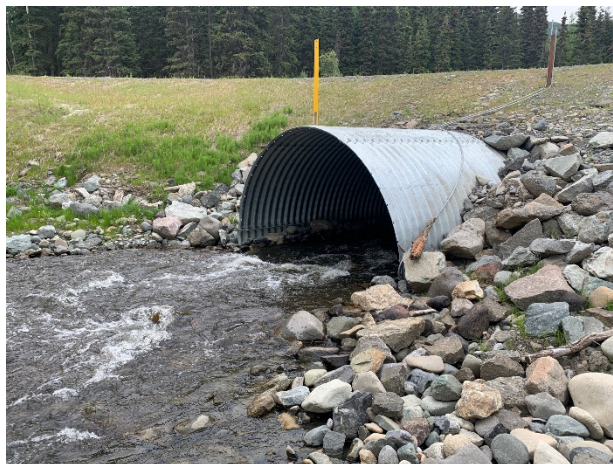
Figure 6-22. Crystal Creek (MC 9), Looking Upstream (post-improvement project)

The DOT&PF project (NFHWY00538/0850(029)) was completed in the summer of 2022, in partnership with the FHWA. The project reconstructed approximately 750 feet of the McCarthy Road at the Crystal Creek crossing. The project replaced three undersized and deteriorating culverts with a new 13.3-foot by 9.3-foot structural plate arch pipe culvert. The new culvert structure will improve the ability for fish, specifically coho salmon and trout, to pass through safely. The before and after photos show the resolution of the previously perched culvert, which was impeding fish passage. The roadway grade was also slightly raised and shifted to improve driver safety and comfort.

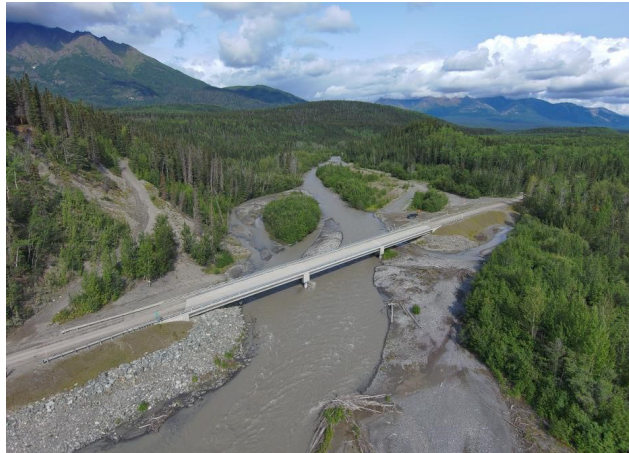
Figure 6-23. Lakina River Bridge (BR 1195), Upstream Looking Downstream

The Lakina River is a braided river upstream and downstream from the Lakina River bridge. The bridge abutments and piers are armored with moderately sized riprap. The river shows signs of migration outside its existing bank. The channel bed consists of cobbles and rock. It has been observed that tree-sized debris appear to frequently get caught along the banks and dried portions of the riverbed and floodplain approximately 3 feet above normal water level.

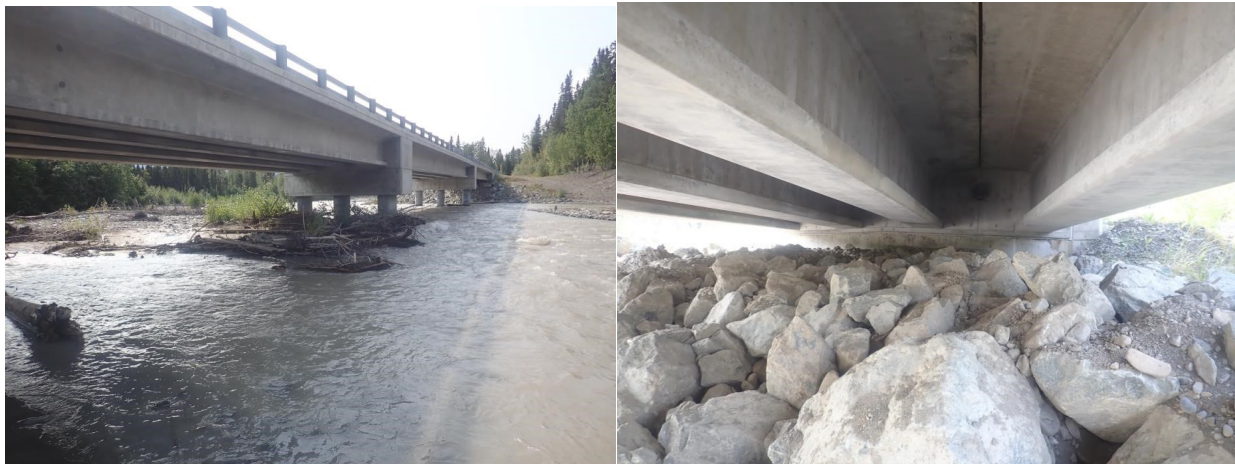
Figure 6-24. Lakina River Bridge (BR 1195), Looking Upstream, Piers and Right Abutment

Figure 6-23 and Figure 6-24 show the Lakina River bridge crossing. Near MP 44, Lakina River crosses the McCarthy Road within a 336-foot, triple-span bridge structure (BR 1145) built in 2016. The bridge is skewed approximately 30 degrees to the river.

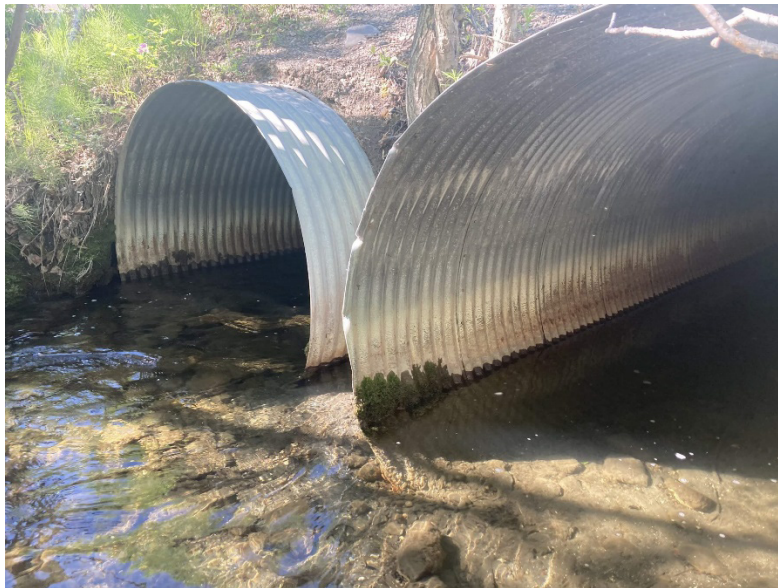
Figure 6-26. Long Lake Creek Cross Culvert (MC 8), Downstream Looking Upstream

Figure 6-25 and Figure 6-26 show the Long Lake crossing. Near MP 45.3, the outlet to Long Lake crosses the McCarthy Road from the northeast within a dual 72-inch CSP culvert structure. This structure, named MC 8 by the CRWP database, was observed to be in good condition.

Upstream from the corridor major crossing, Long Lake flows northeast to southwest to feed the Long Lake Creek. The creek does not show signs of potential migration outside its existing banks because these banks are heavily vegetated.

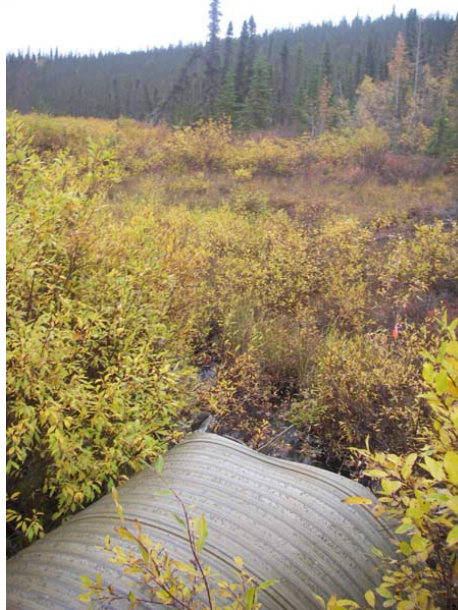
Figure 6-27. Long Lake Creek Crossing (MC 7), Looking Upstream

The upstream area is a somewhat flat vegetated wetland. Downstream of the corridor crossing, the creek does not show signs of potential migration outside its existing banks because the banks are relatively steep and somewhat vegetated.

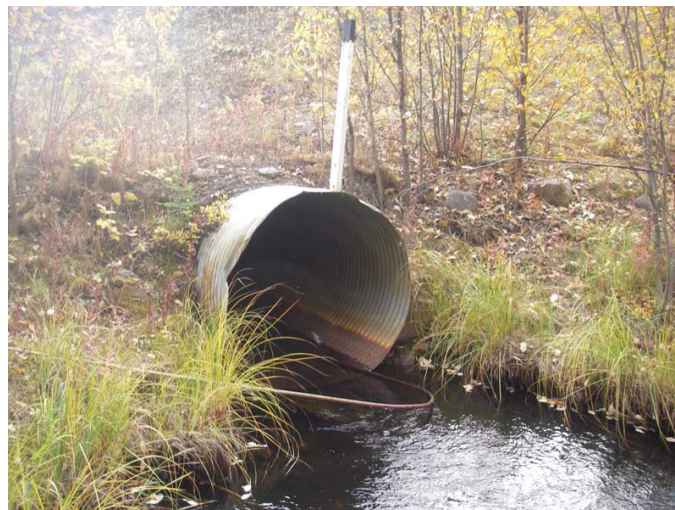
Figure 6-28. Long Lake Creek Crossing (MC 7), Downstream Looking Upstream

Figure 6-27 and Figure 6-28 show the Long Lake Creek crossing. Near MP 47.9, Long Lake Creek crosses the McCarthy Road from the southeast within a 60-inch CSP culvert structure. This structure, named MC 7 by the CRWP database, was observed to be in good condition.

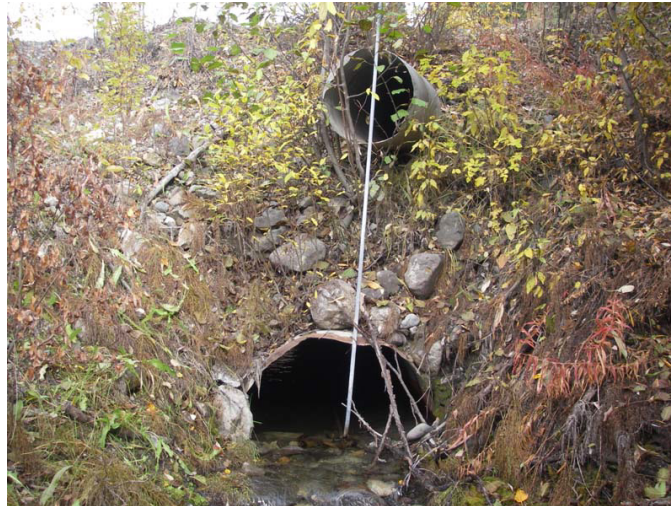
Figure 6-29. Tractor Creek Cross Culvert (MC 3), Downstream Looking Upstream

The condition of the existing cross culvert appears to be deteriorating. The upstream area is a somewhat flat, heavily vegetated area. The upstream and downstream roadway side slopes are armored with moderately sized riprap protecting the area around the culvert from erosion.

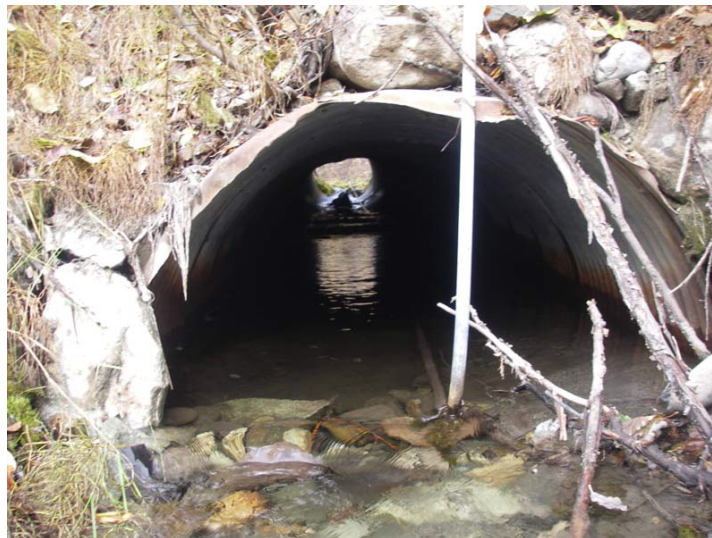
Figure 6-30. Tractor Creek Cross Culvert (MC 3), Upstream Looking Downstream

Figure 6-29 and Figure 6-30 show the Tractor Creek crossing. Near MP 53.5, Tractor Creek crosses the McCarthy Road from the north within a 48-inch CSP culvert structure. This structure, named MC 3 by the CRWP database, was observed to be in good condition.

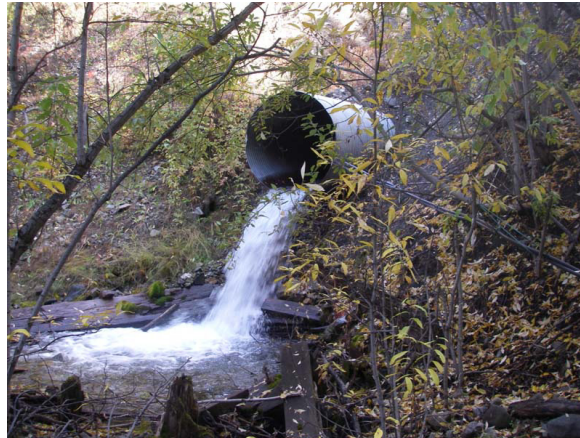
Figure 6-31. Swift Creek Crossing (MC 2), Downstream Looking Upstream

The cross culvert appears to be in great condition. Riprap armoring is not present on the roadway side slopes around the culvert inlet or outlet. Roadway side slopes are in danger of erosion around the culvert inlet and outlet. The DOT&PF M&O staff has recommended that this culvert be repaired.

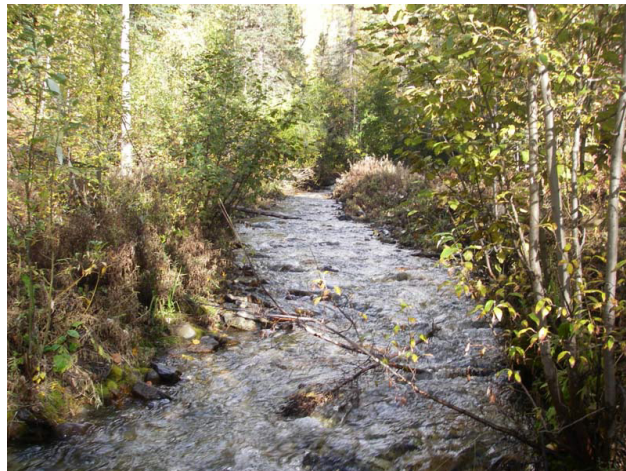
Figure 6-32. Swift Creek Crossing (MC 2), Looking Upstream

Figure 6-31 and Figure 6-32 show the Swift Creek crossing. Near MP 56.1, Swift Creek crosses the McCarthy Road from the north within a 72-inch CSP culvert structure. This structure, named MC 2 by the CRWP database, was observed to be in good condition.

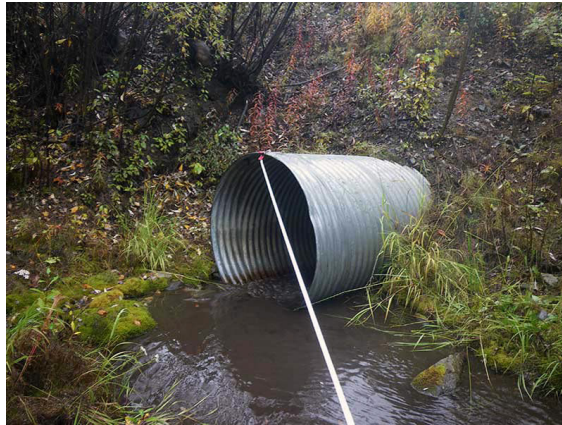
Figure 6-33. Farm Creek Cross Culvert (MC 1), Upstream Looking Downstream

Figure 6-33 and Figure 6-34 show the Farm Creek crossing. Near MP 57.3, Farm Creek crosses the McCarthy Road from the west within a 48-inch CSP culvert structure. This structure, named MC 1 by the CRWP database, was observed to be in good condition.

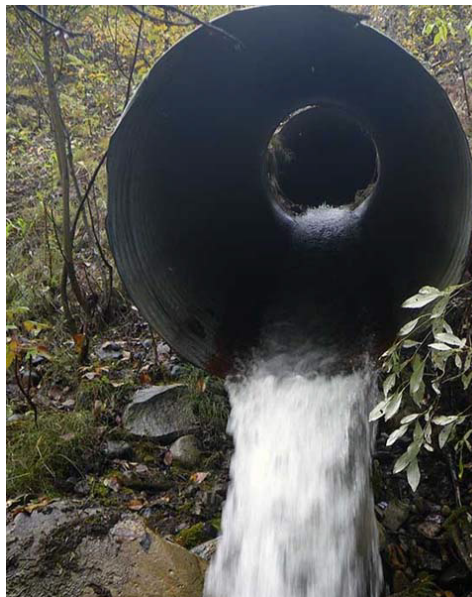
Figure 6-34. Farm Creek Cross Culvert (MC 1), Downstream Looking Upstream

The creek does not show signs of potential migration outside its existing banks because these banks are heavily vegetated. Farm Creek flows southeast to combine with the Kennicott River.

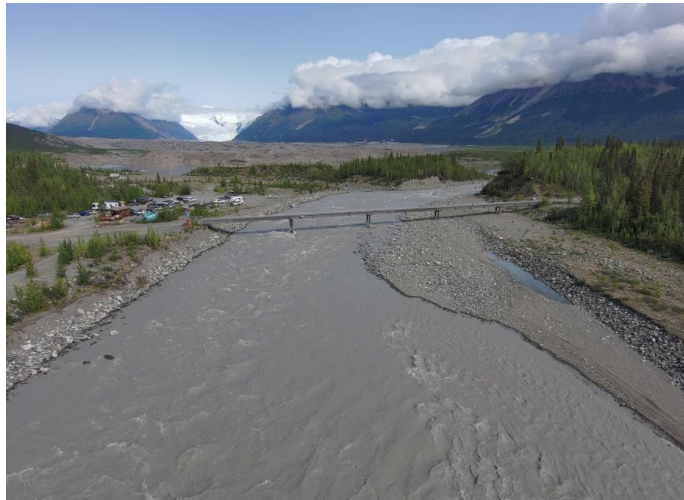
Figure 6-35. Kennicott River Bridge (BR 6004), Downstream Looking Upstream

Figure 6-35 shows the Kennicott River bridge (west) crossing. Near MP 59.3, the Kennicott River crosses the pedestrian bridge immediately east after the McCarthy Road dead ends at a parking lot. While the bridge is referred to by many as the DOT&PF “footbridge,” ATVs do traverse the bridge; passenger vehicles are not allowed. The Kennicott River crosses within a 450-foot-long, five-span bridge (BR 6004) built in 1997.

The bridge abutments are armored with large-sized riprap. The river does not show signs of potential migration outside its existing banks because these banks are fairly steep. Erosion is observed to exist on the west bank where there now exists large riprap to protect the bank. The riverbed is composed of primarily silt, cobble, and boulder material.

Local observations have noted frequent glacial outbursts that result in flooded water surface elevations approximately 2 to 3 feet below the bridge girders. These outbursts have also coincided with heavy streambed erosion (approximately 9 feet as observed by the locals). M&O crews have recommended the need for more erosion protection on the northwest riverbank.

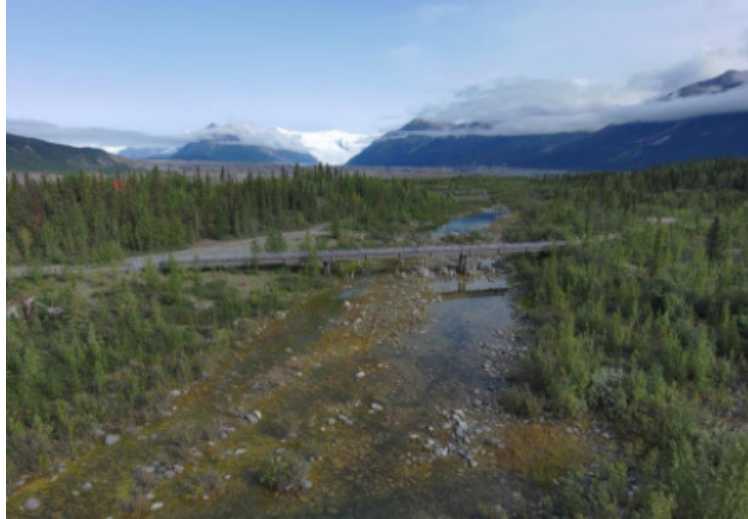
Figure 6-36. Kennicott River Bridge (BR 6005), Downstream Looking Upstream

Figure 6-36 and Figure 6-37 show the Kennicott River bridge (east) crossing. Near MP 59.8, a pedestrian bridge crosses the east channel of the Kennicott River. This channel is locally referred to as the “dry channel.” This bridge is a 270-foot-long, three-span pedestrian bridge built in 1997. This bridge is downstream of roadway culverts that convey Clear Creek flows under a rerouted portion of the main road. A community swimming hole is immediately adjacent to and north of the rerouted portion of the main road in this location.

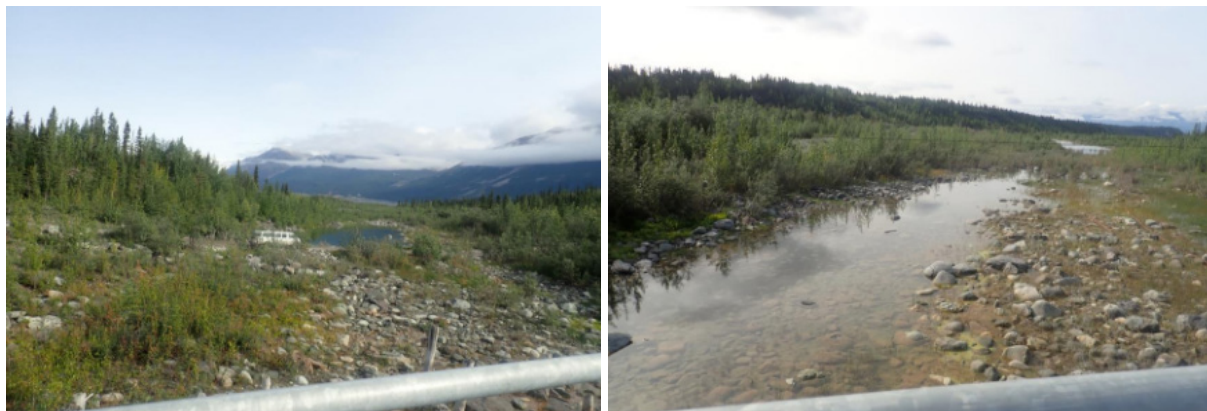
Figure 6-37. Kennicott River Bridge (BR 6005), Looking Upstream and Looking Downstream

Clear Creek is frequently dry with a creek bed consisting of primarily silt, cobbles, and boulders with minimal risk of erosion.
